Use Attainability Analysis  
for  
WBID 3236 South Fork Capps Creek

Submitted by  
SES Inc.  
to  
Missouri Department of Natural Resources  
Water Protection Program

**Field Data Sheets for Recreation Use Stream Surveys**  
**Data Sheet A - Water Body Identification**  
(For water body being surveyed)

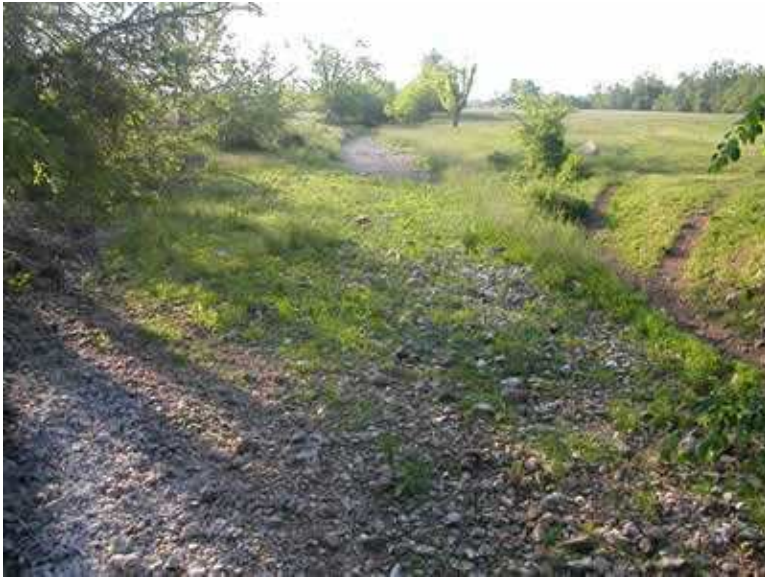
**Site# 1 Photo ID# 98, Upstream**

**WBID #** 3236      **Site #** 1  
**Mark #** 50      **Dissolved Oxygen (ppm)** N/A  
**Upstream Views Physical Dimensions:** Is there any water present at this view? no  
 If so, is there an obvious current? no

Vegetation in dried stream.

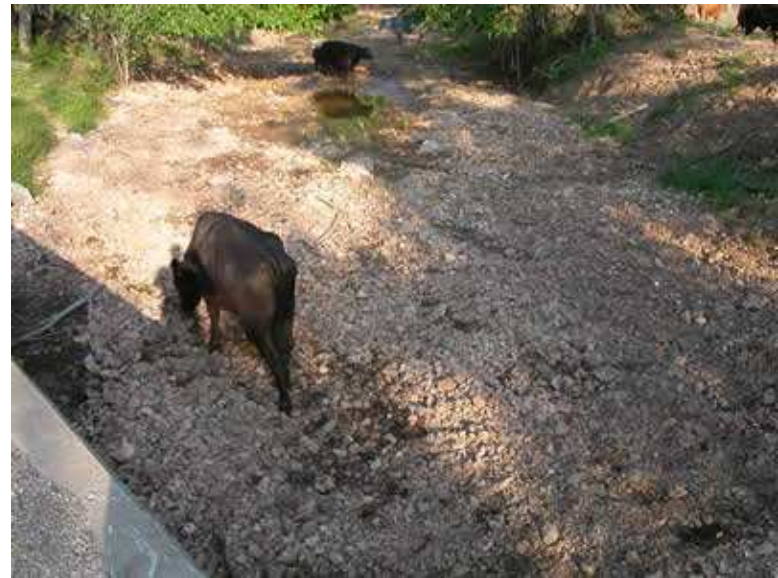
Roads	Rope swings	Foot paths/prints	Dock/platform
<b>Livestock Watering</b>	RV/ATV Tracks	Camping Sites	Fire pit/ring
<b>Pic # 99</b>			
NPDES Discharge	Fishing Tackle	Other:

% Cobble	% Gravel	% Sand	% Silt
50	50	0	0
% Mud/Clay	% Bedrock		
0	0

**Site# 1 Photo ID# 99, Downstream / Livestock watering**

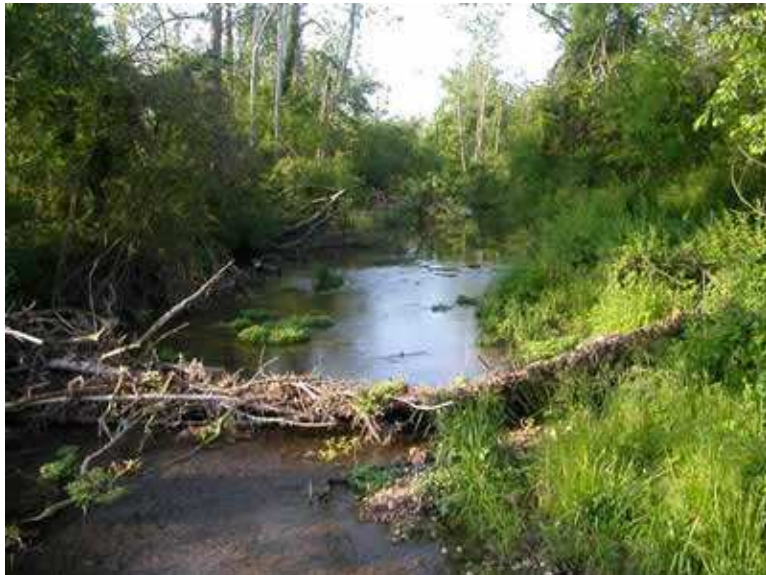
**Site# 2 Photo ID# 100, Upstream**

**WBID #** 3236      **Site #** 2  
**Mark #** 51      **Dissolved Oxygen (ppm)** 8.2  
**Upstream Views Physical Dimensions:** Is there any water present at this view? yes  
 If so, is there an obvious current? yes

% of Channel Feature				
Riffle	18				
Run	9				
Pool	73

Little algae on rocks. Vegetation along banks. Little filamentous algae. Aquatic cloverlike vegetation.

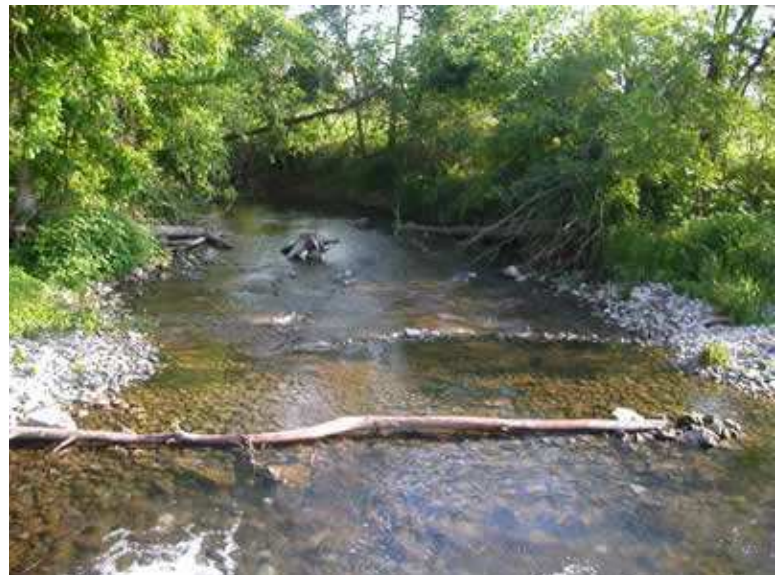
**Site# 2 Photo ID# 101, Downstream**

% Cobble	% Gravel	% Sand	% Silt
35	35	0	25
% Mud/Clay	% Bedrock		
0	5

Odor	Sewage	Musky	Chemical	<b>None</b>	Other
Color	<b>Clear</b>	Green	Gray	Milky	Other
Bottom Deposit	Sludge	Solids	Fine Sed.	<b>None</b>	Other
Surface Deposit	Oil	Scum	Foam	<b>None</b>	Other

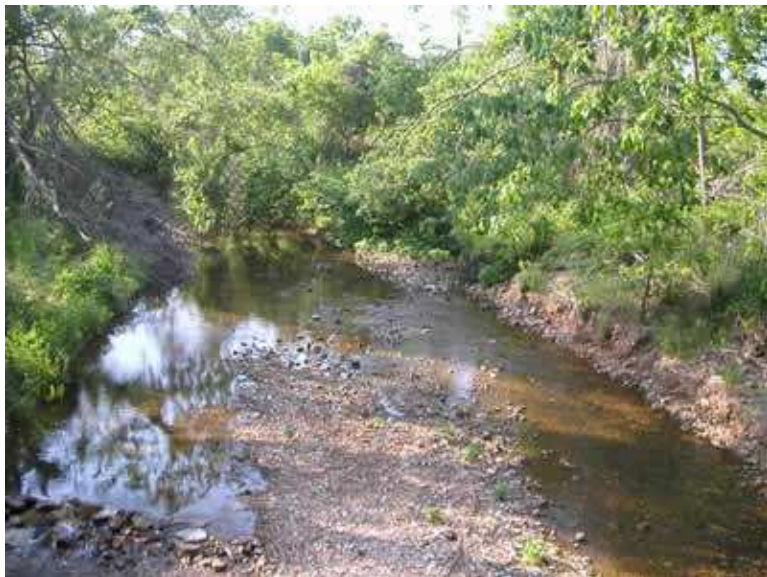
**Site# 3 Photo ID# 103, Upstream**

**WBID #** 3236      **Site #** 3  
**Mark #** 52      **Dissolved Oxygen (ppm)** 8.1  
**Upstream Views Physical Dimensions:** Is there any water present at this view? yes  
 If so, is there an obvious current? yes

% of Channel Feature				
Riffle	37				
Run	0				
Pool	63

Vegetation along bank. Algae on rocks. No floating algae.

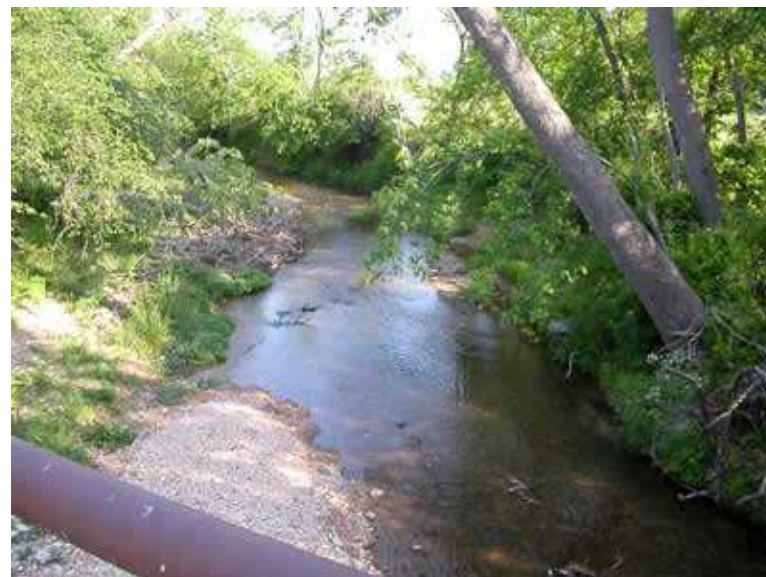
**Site# 3 Photo ID# 102, Downstream**

% Cobble	% Gravel	% Sand	% Silt
36	36	0	28
% Mud/Clay	% Bedrock		
0	0

Odor	Sewage	Musky	Chemical	<b>None</b>	Other
Color	<b>Clear</b>	Green	Gray	Milky	Other
Bottom Deposit	Sludge	Solids	Fine Sed.	<b>None</b>	Other
Surface Deposit	Oil	Scum	Foam	<b>None</b>	Other
